## **AIRCRAFT ACCIDENT INVESTIGATION BOARD**

### **FINAL AIRCRAFT ACCIDENT REPORT FOR A BEECHCRAFT BARON 55, 9J – KMN THAT OCCURRED IN MUMBWA (CHUNGA AERODROME), ZAMBIA ON 10<sup>th</sup> JANUARY, 2020.**

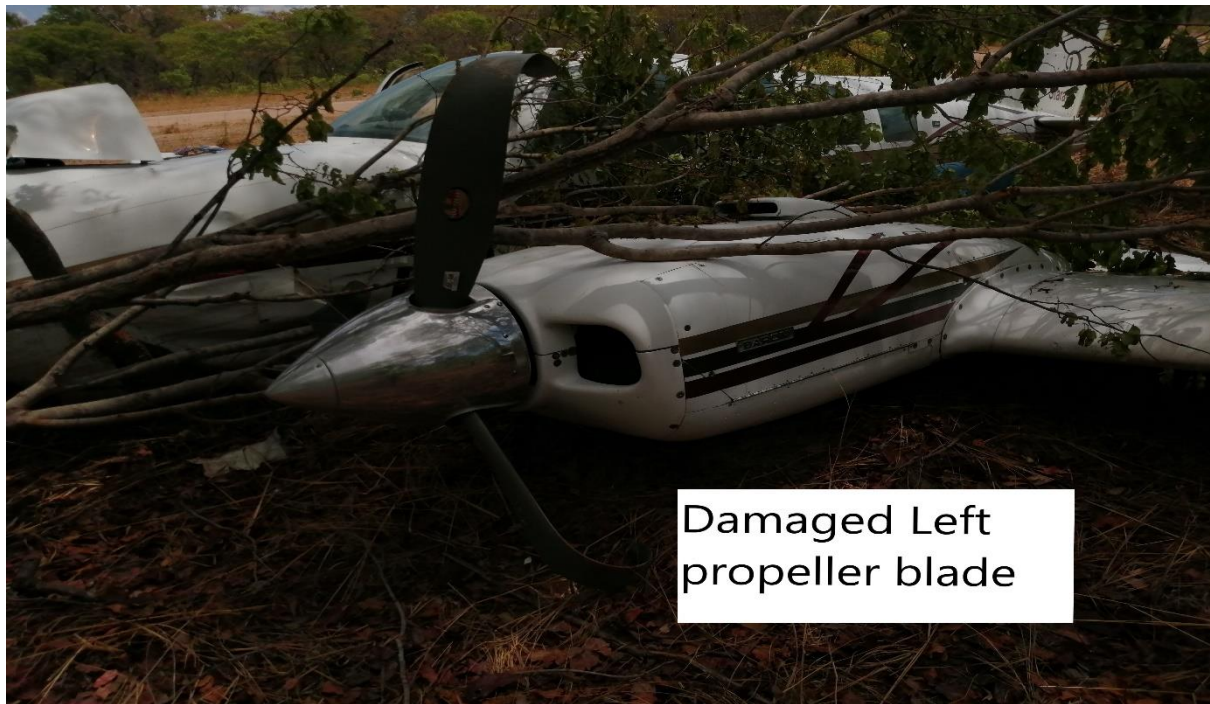
Fig 1.1: Damaged Left Propeller

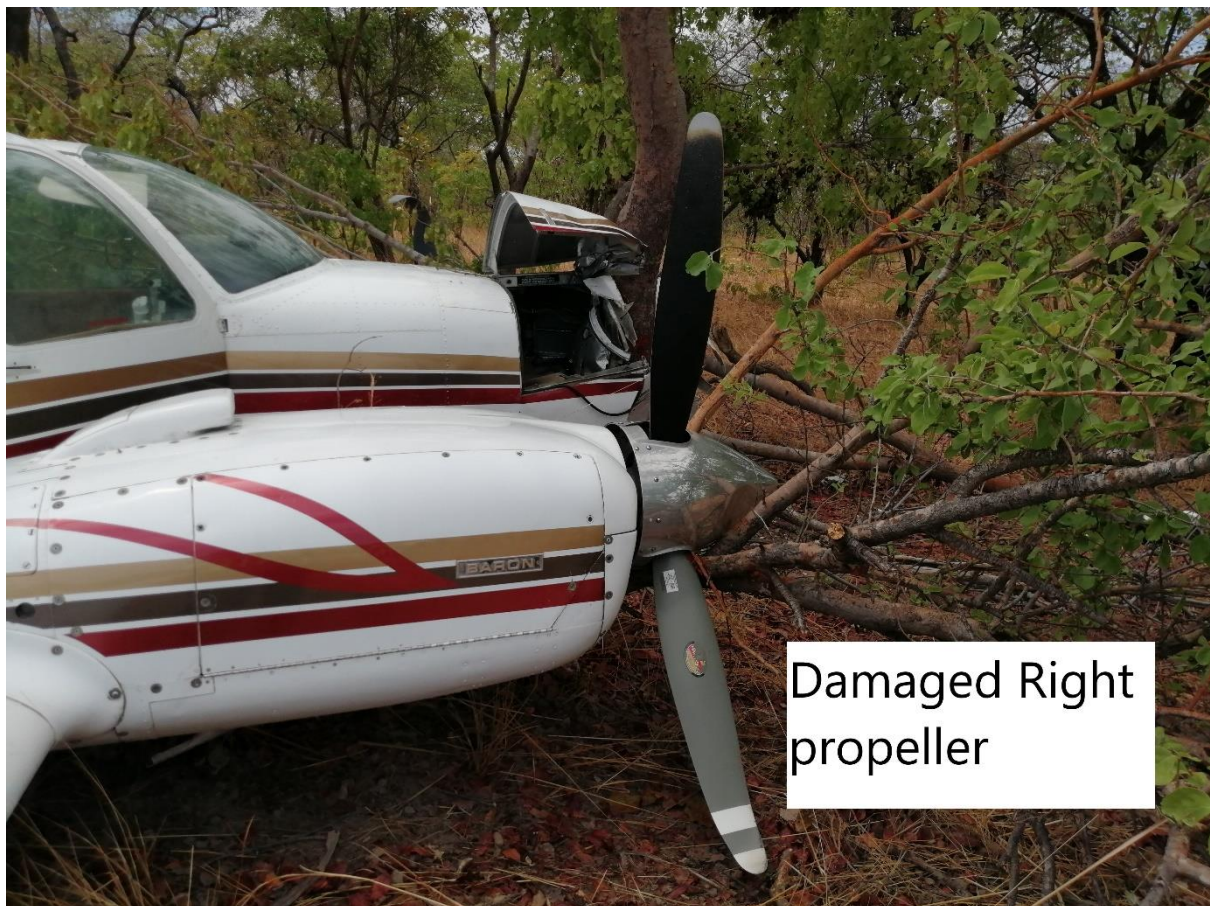
Fig. 1.2: Damaged Right Propeller

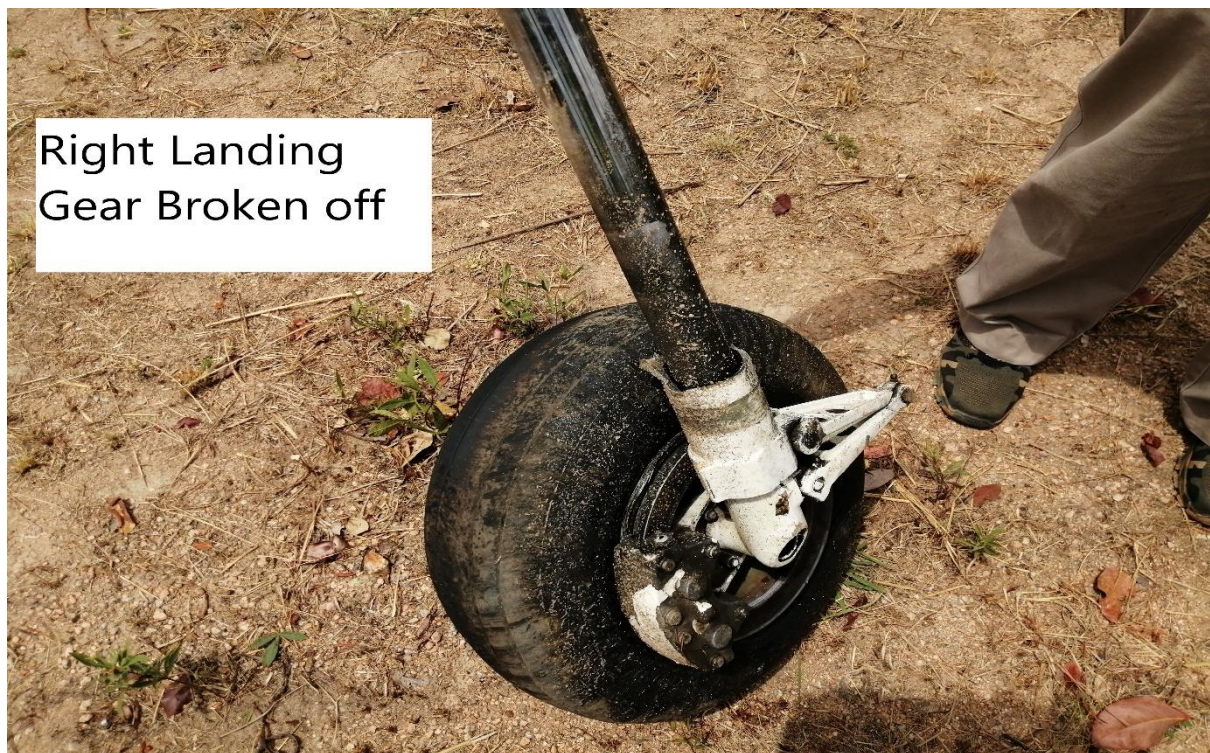
Fig. 2.1: Right Landing Gear

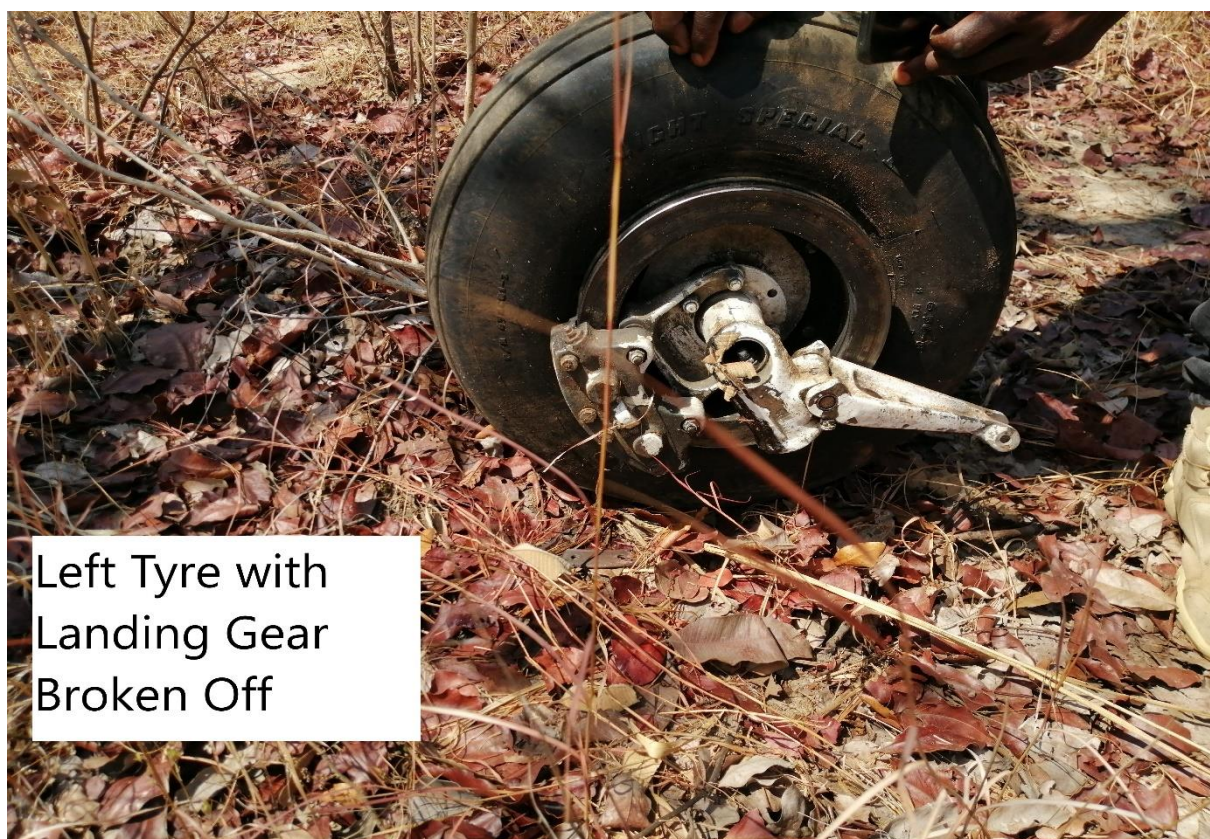
Fig. 2.2: Left Landing Gear

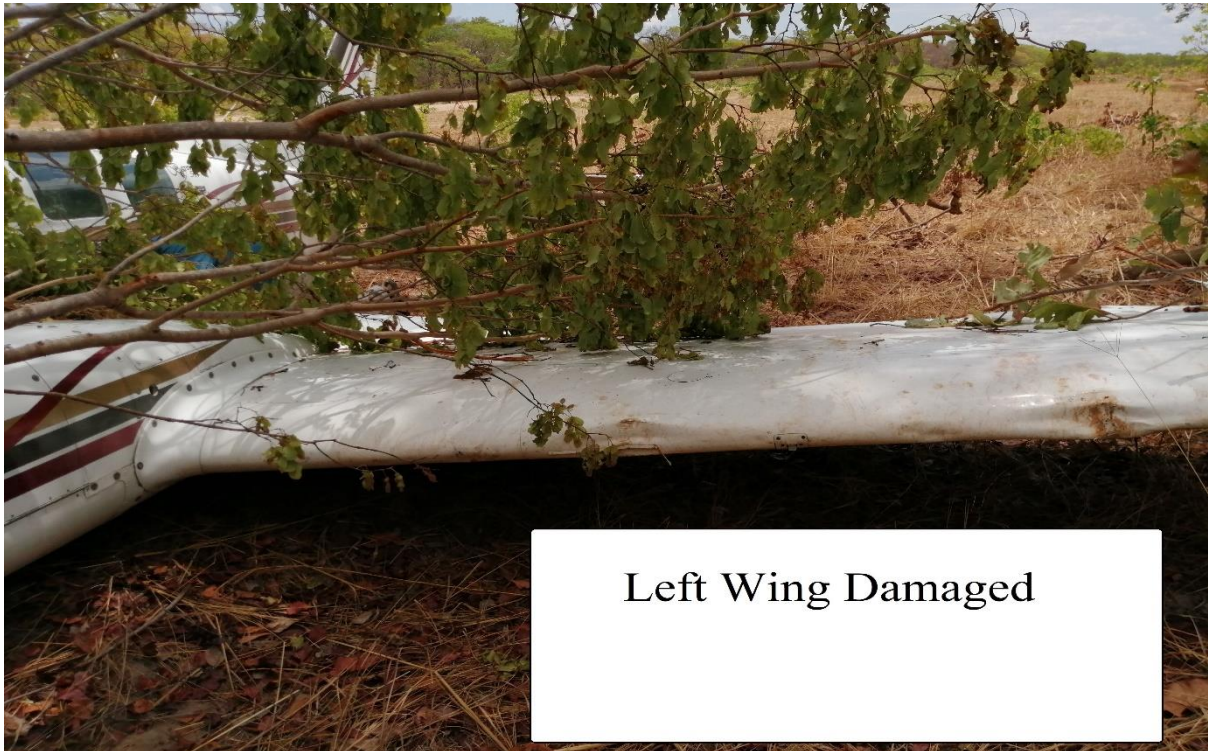
Fig. 3.1: Left Wing Damaged

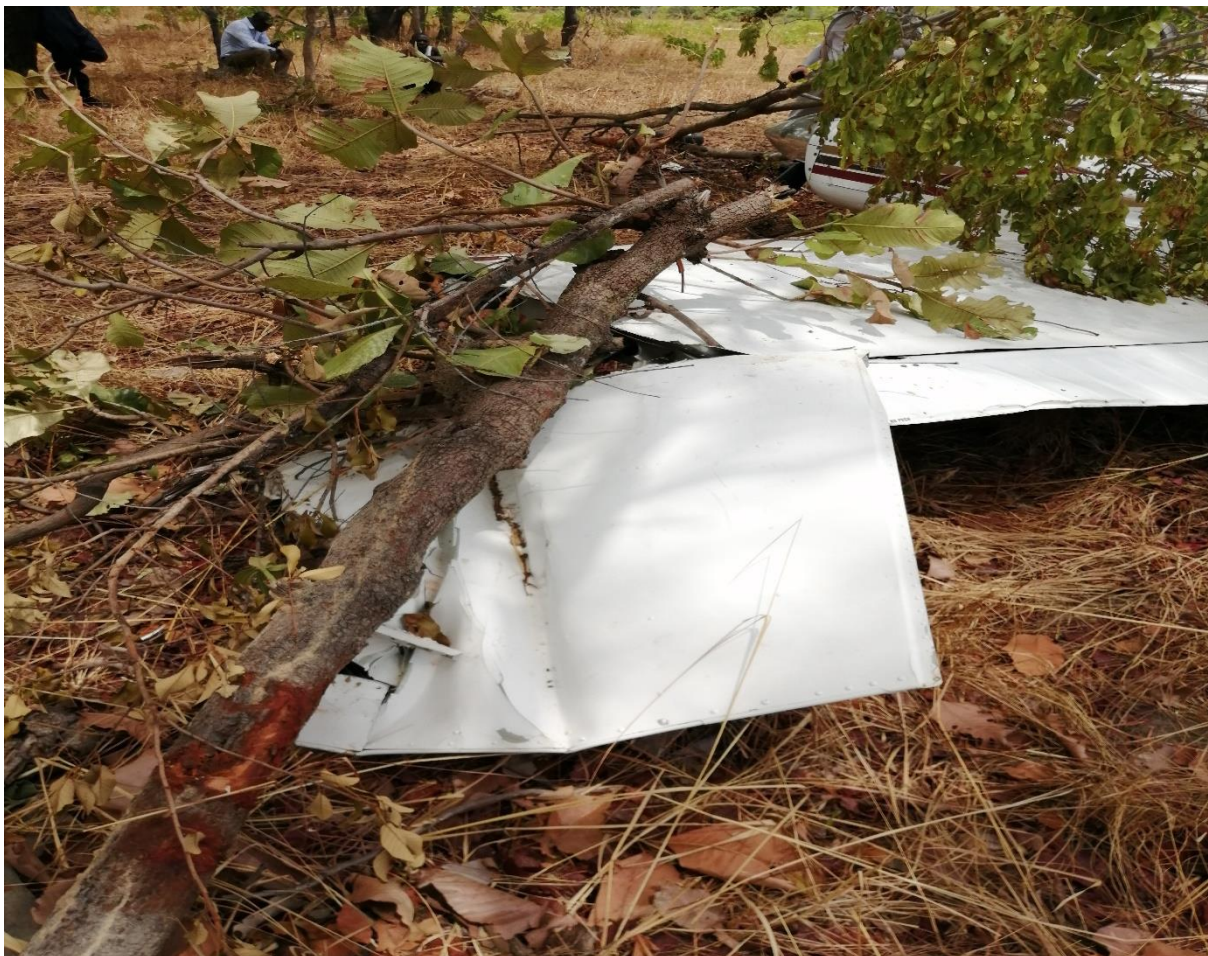
Fig. 3.2: Right Wing Damaged

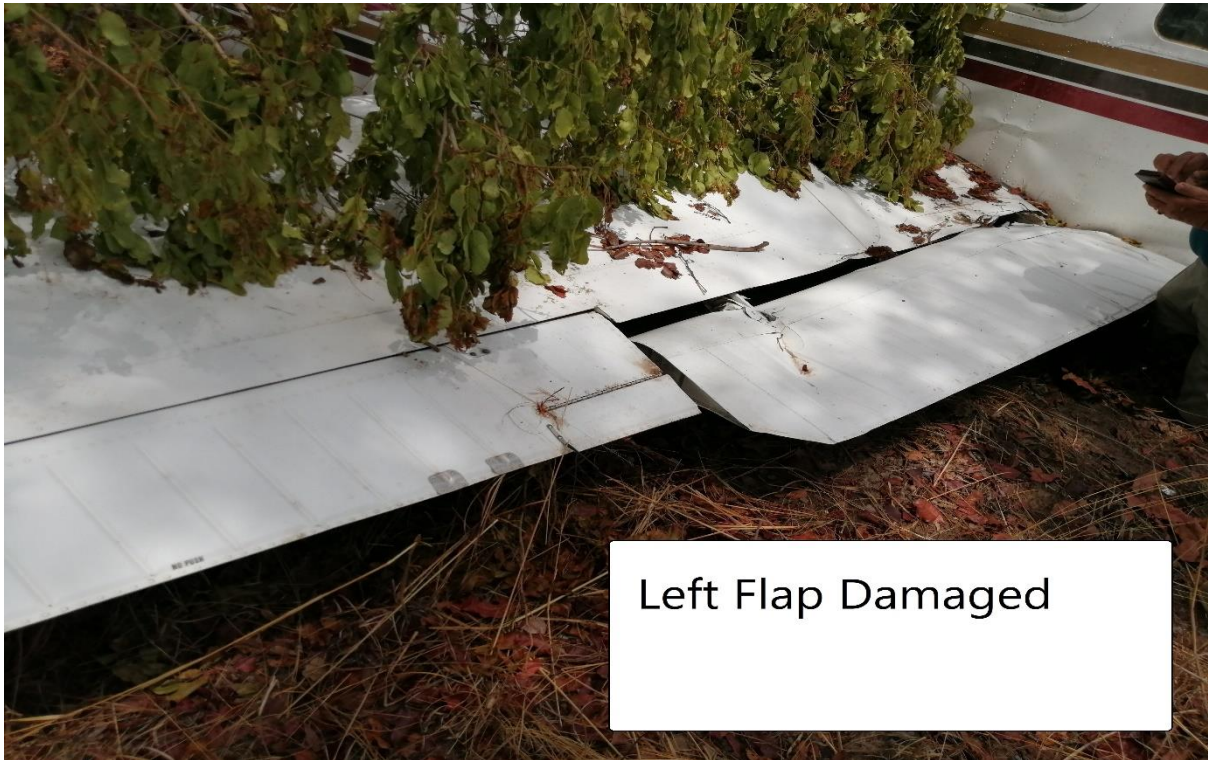
Fig. 4.1: Left Flap Damaged

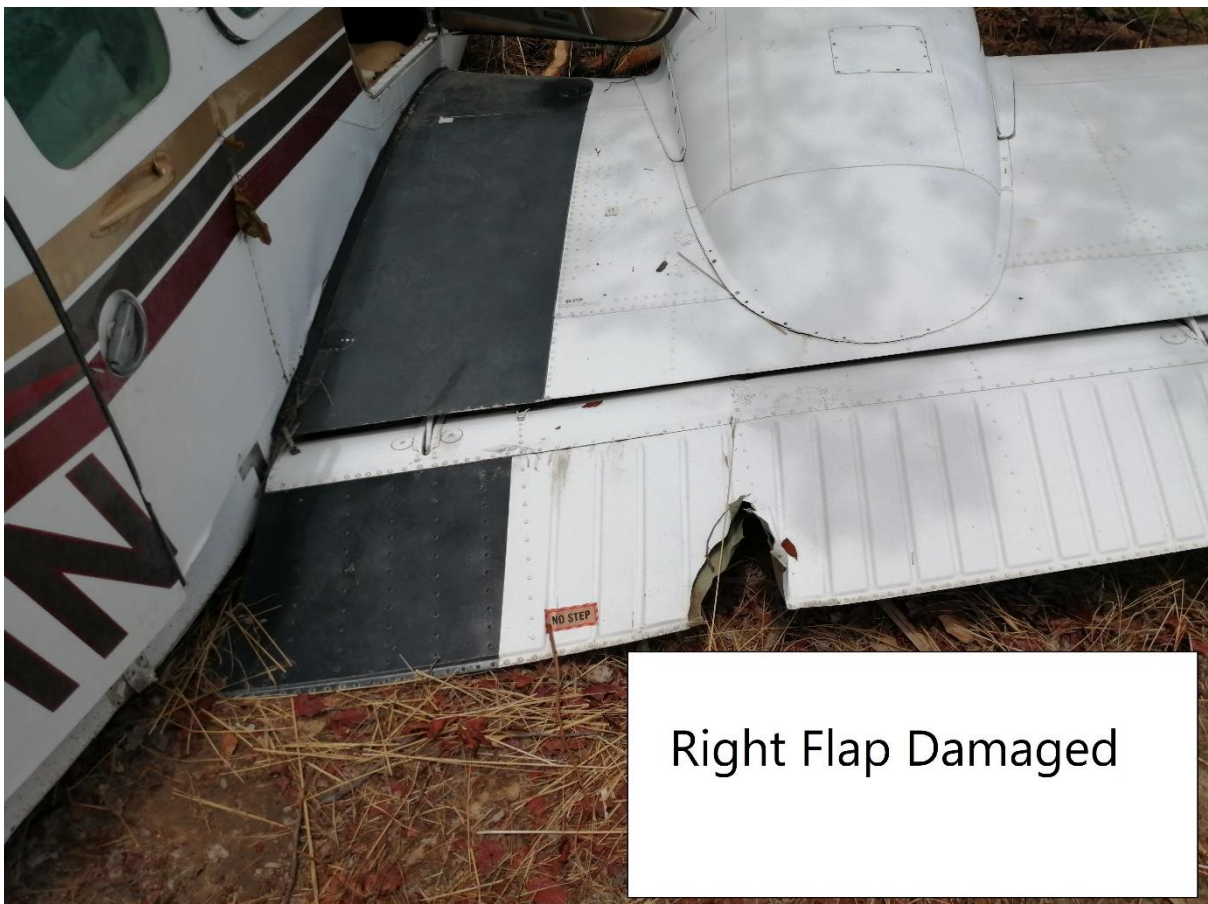
Fig. 4.2: Right Flap Damaged

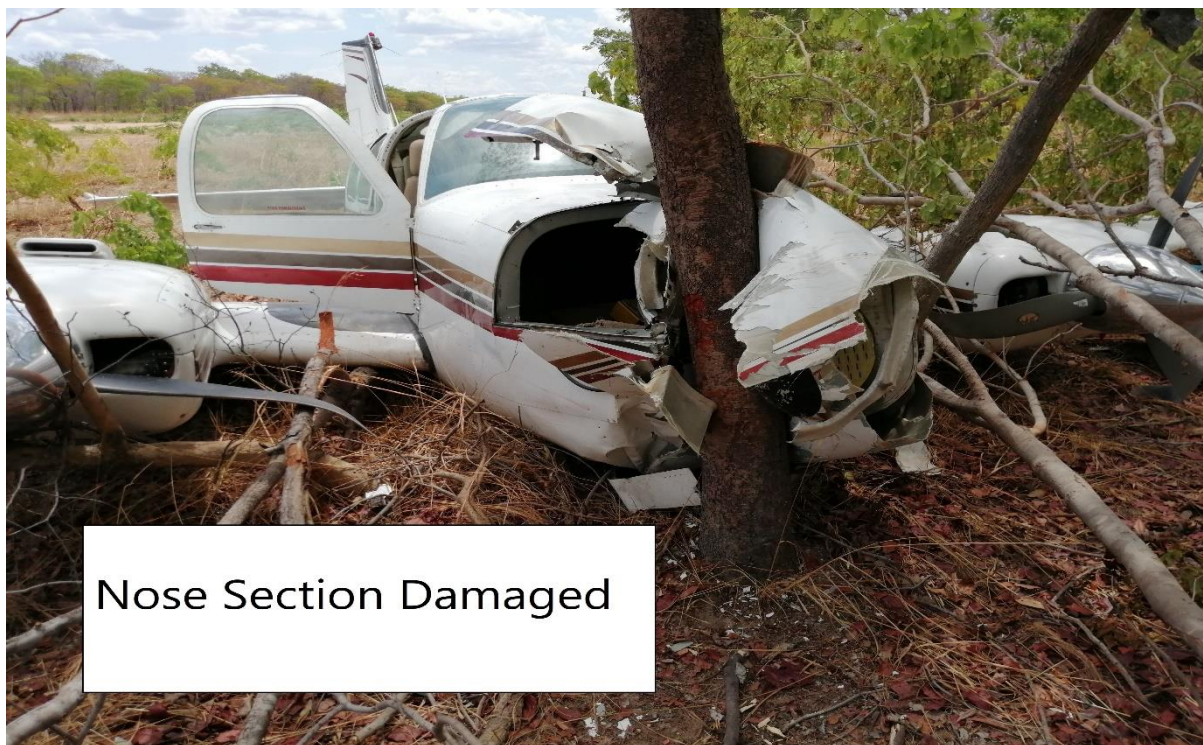
The aircraft crashed three hundred and twenty meters from the beginning of the runway 080. There were no skid marks noted until the aircraft came to rest at some point. The left wing impact damage was between the wing root and the left engine. The left wing uprooted two trees that managed to slow down the aircraft (Fig. 7). The right wing also collided with two trees. The aircraft came to a stop when the aircraft nose wedged itself between two more trees (Fig.5 and Fig. 8).

Fig. 5: Nose Section Damaged

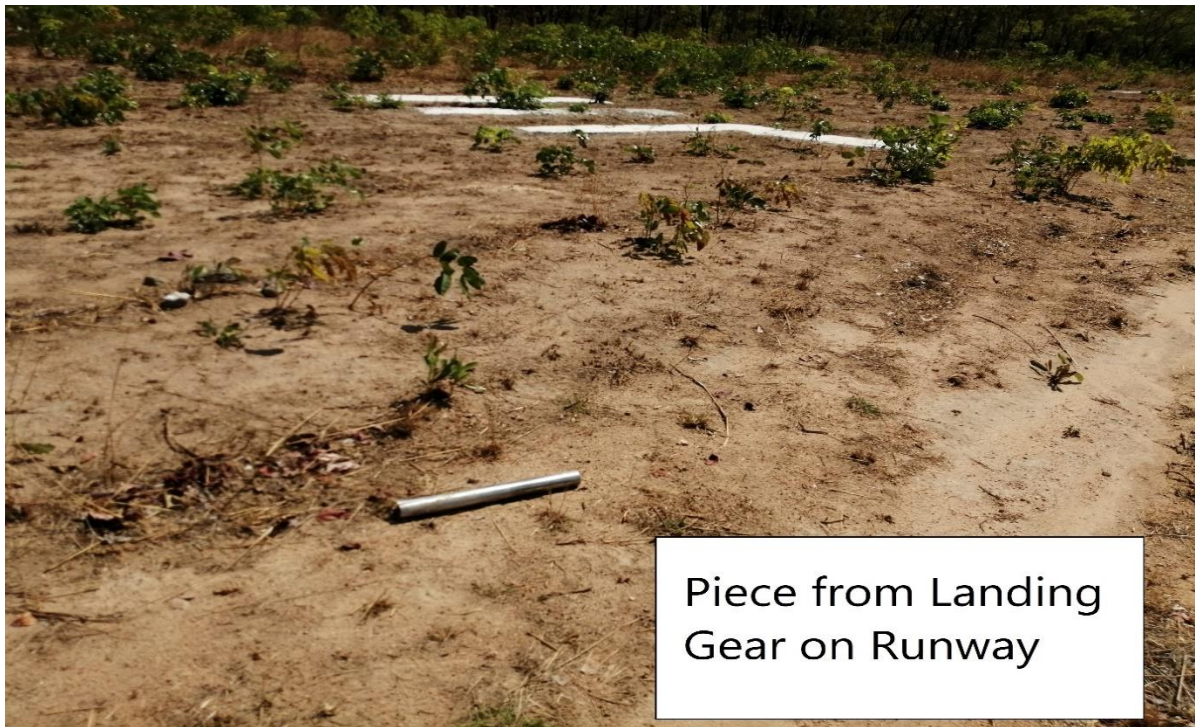
Fig. 6: Piece from Landing Gear

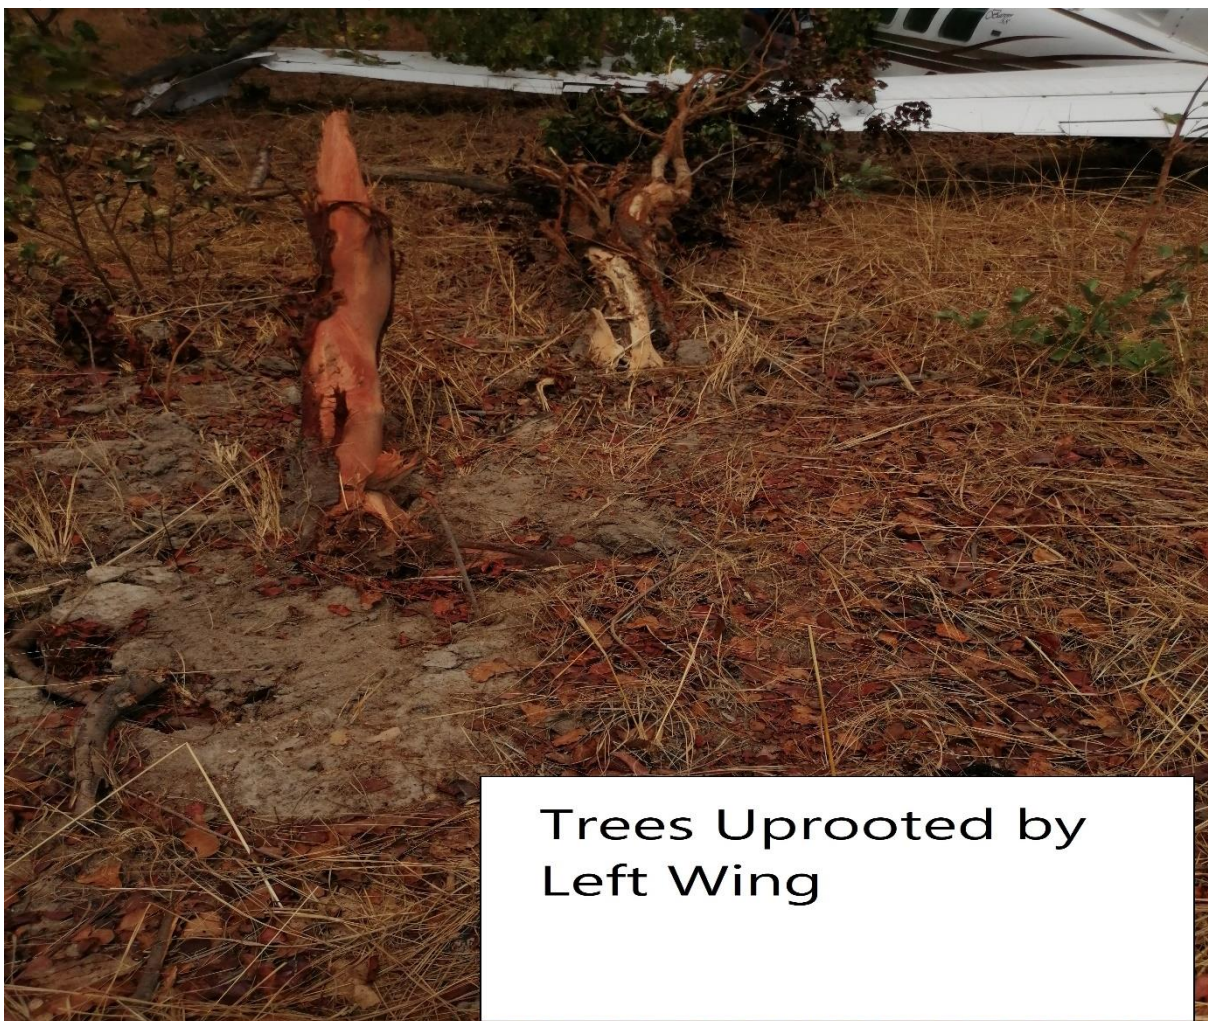
Fig. 7: Trees Uprooted by Left Wing

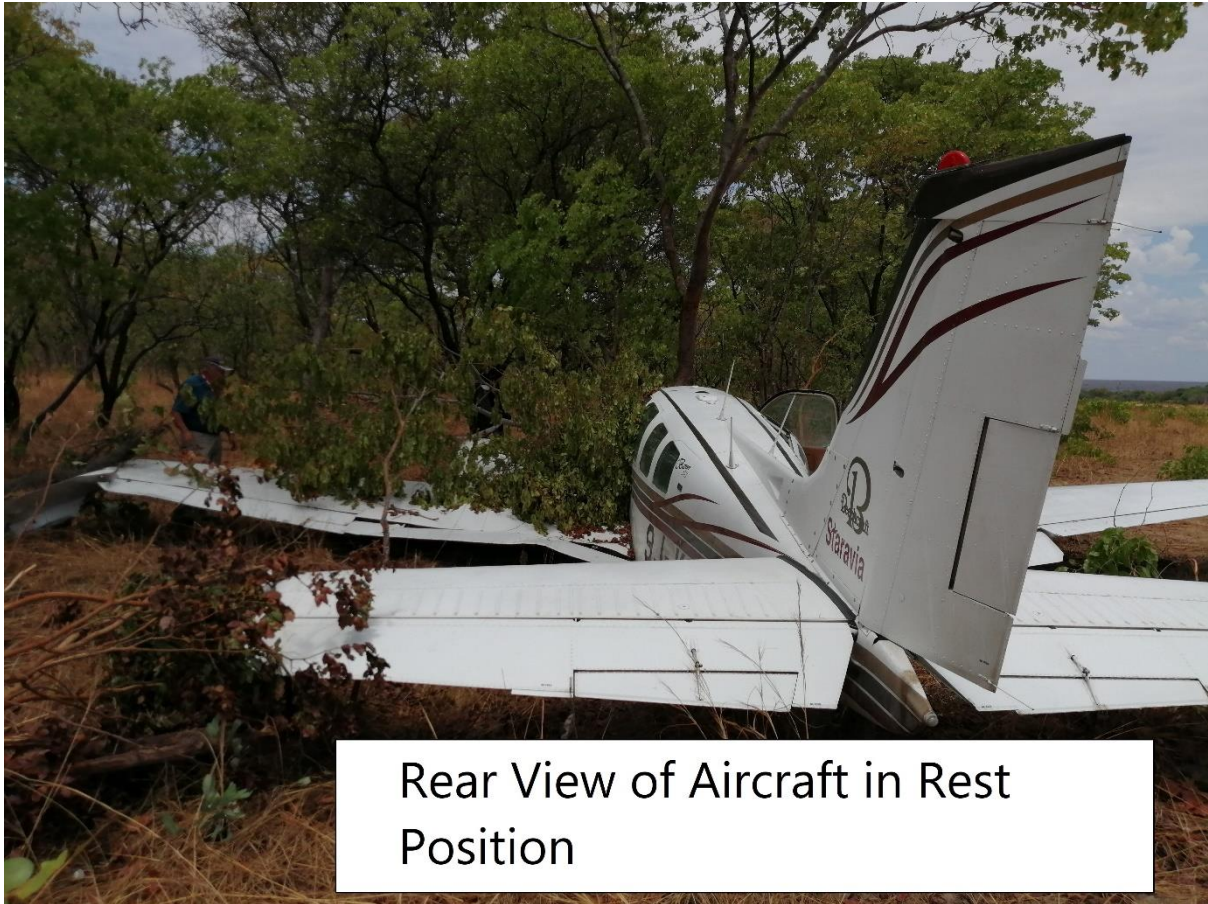
Rear View of Aircraft in Rest Position

Fig. 8: Rear View of Aircraft
