AIRCRAFT ACCIDENT INVESTIGATION BOARD

FINAL AIRCRAFT ACCIDENT REPORT FOR A TANARG NEO MICROLIGHT, 9J – YVT THAT OCCURRED IN LIVINGSTONE, ZAMBIA ON 10th JANUARY, 2020.

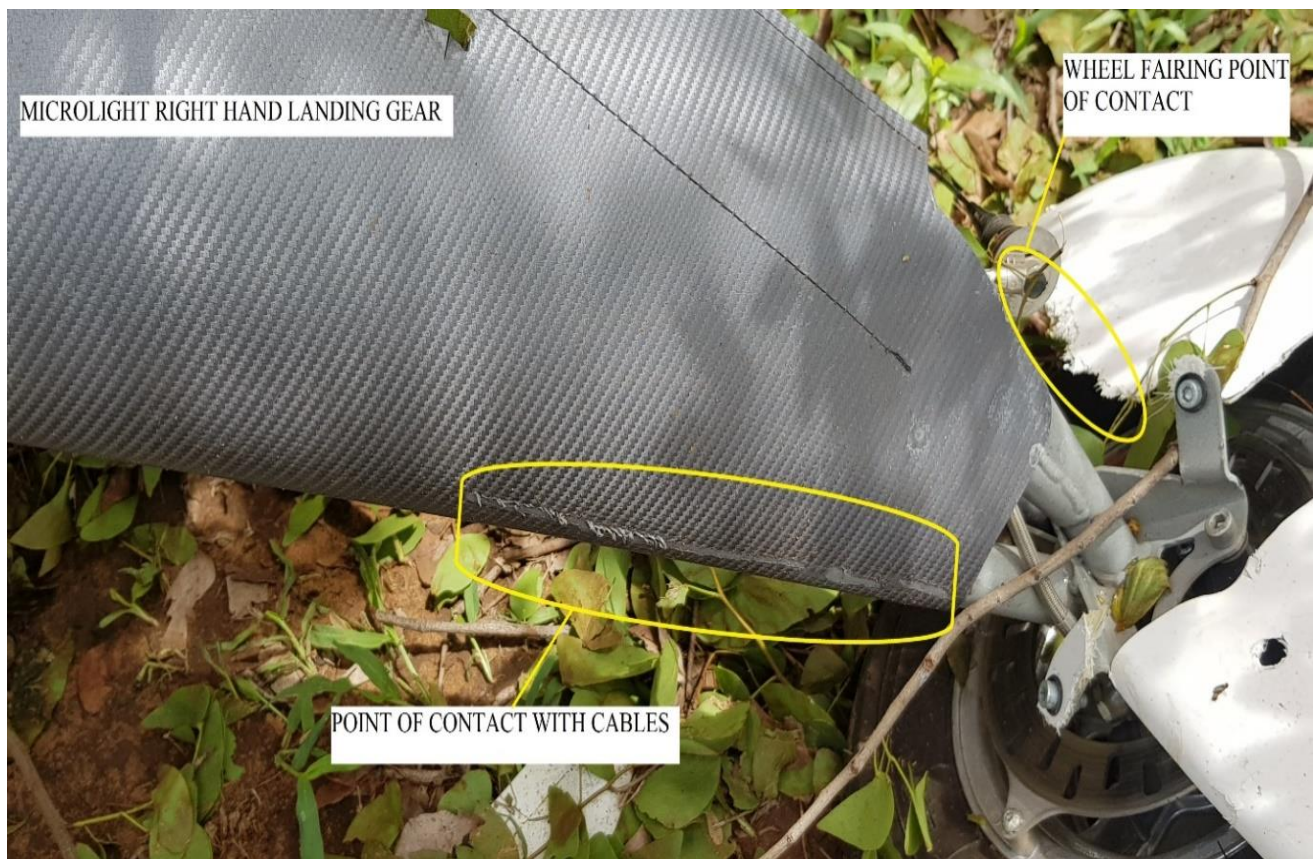
The Microlight rear right wheel ended up hooking in the power lines (Fig.2, Fig 4.2) pitching the aircraft forward and simultaneously swinging the nose end to the right, initiating an uncontrolled spin. It crashed into the bushes 15 meters ahead of the Power lines on the left-hand side of the gravel road leading to Baobab Ridge Helipad (Fig 6.1 – Fig. 6.4).

(2) Fairings Damaged (Fig. 2)

Forward and aft cross gears were in place with the lower right main leg clearly showing where the 11kV ZESCO cables had scratched. (Fig. 2)

Fig 2: First point of contact and breaking of fairing

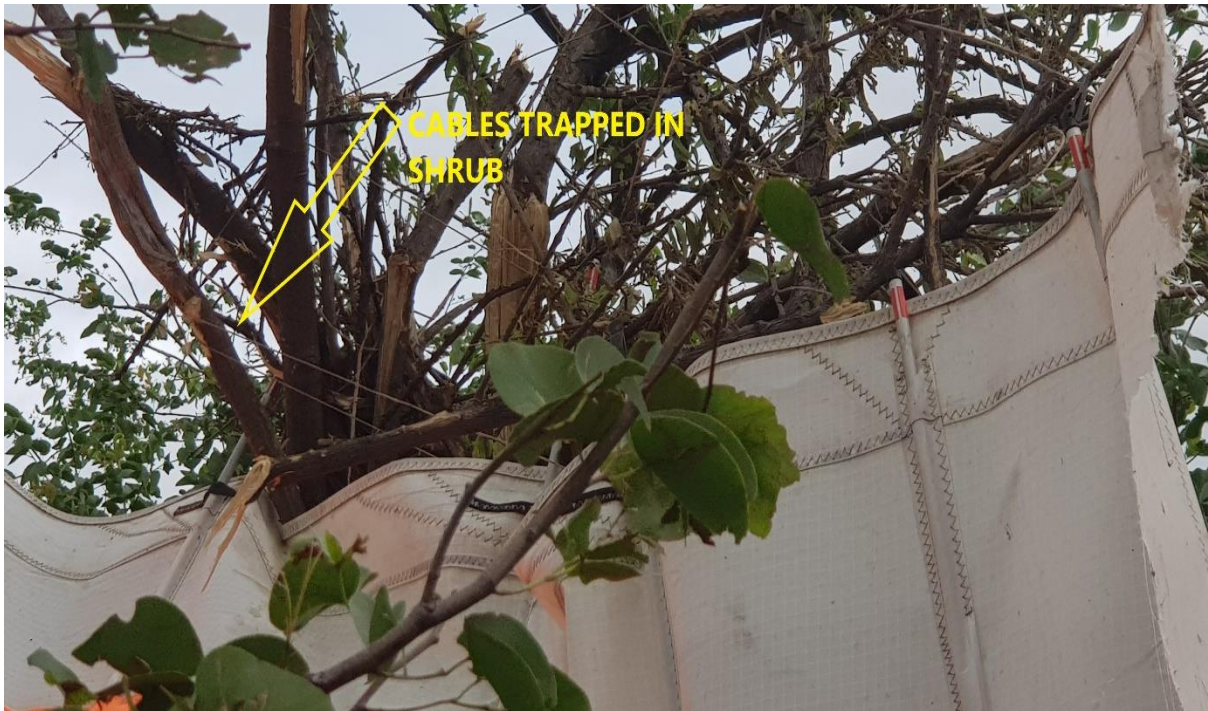
Fig. 3 Power Cable in Shrub

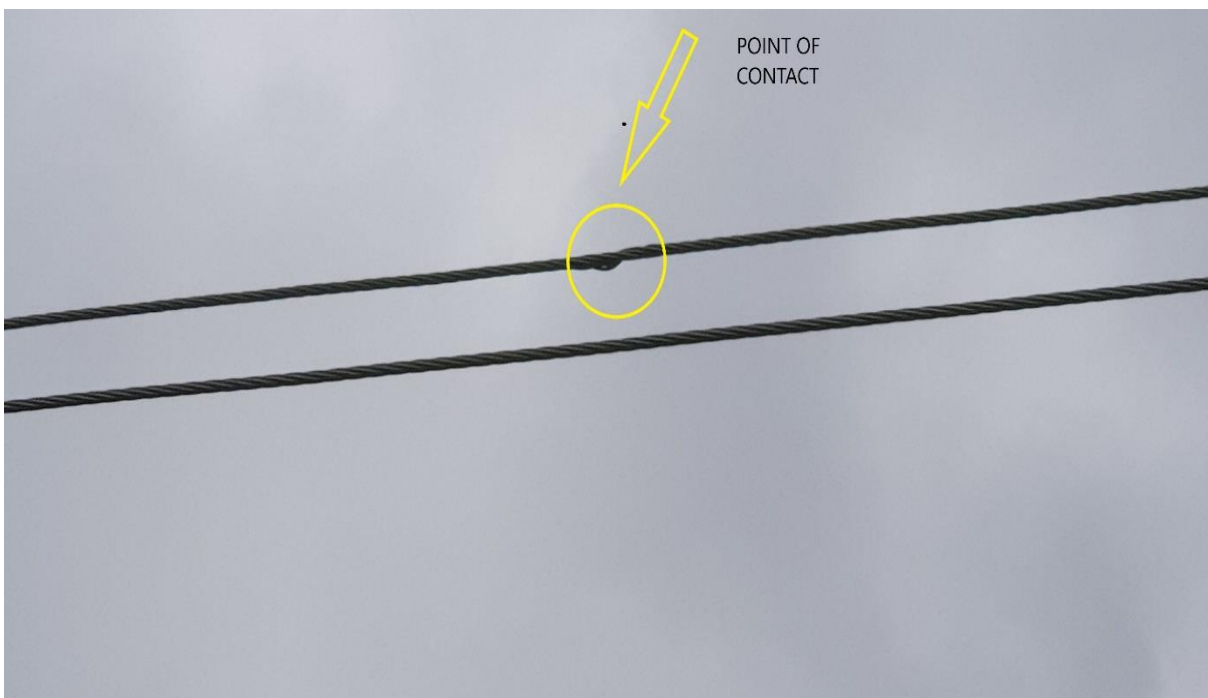
Fig.4.1 Point of Contact on Power Cable

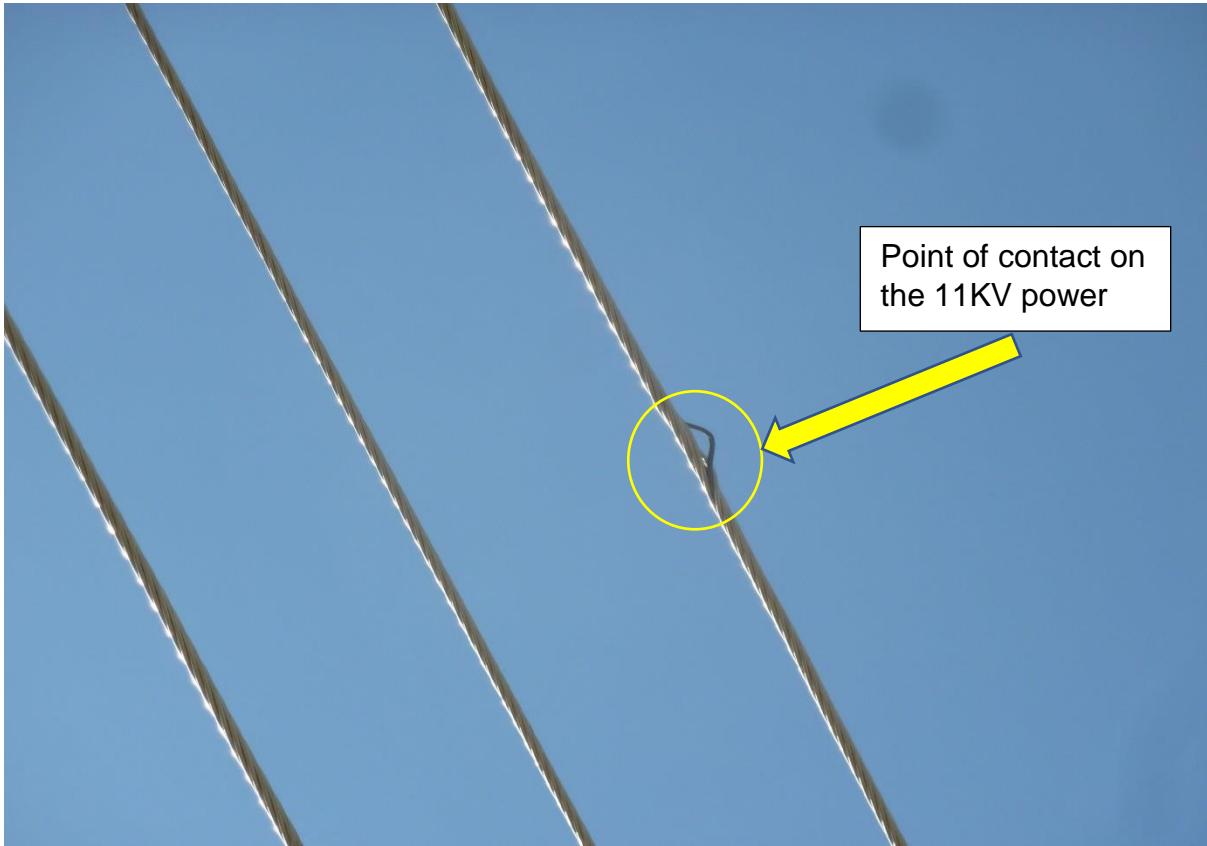
Fig.4.2 Point of Contact on Power Cable

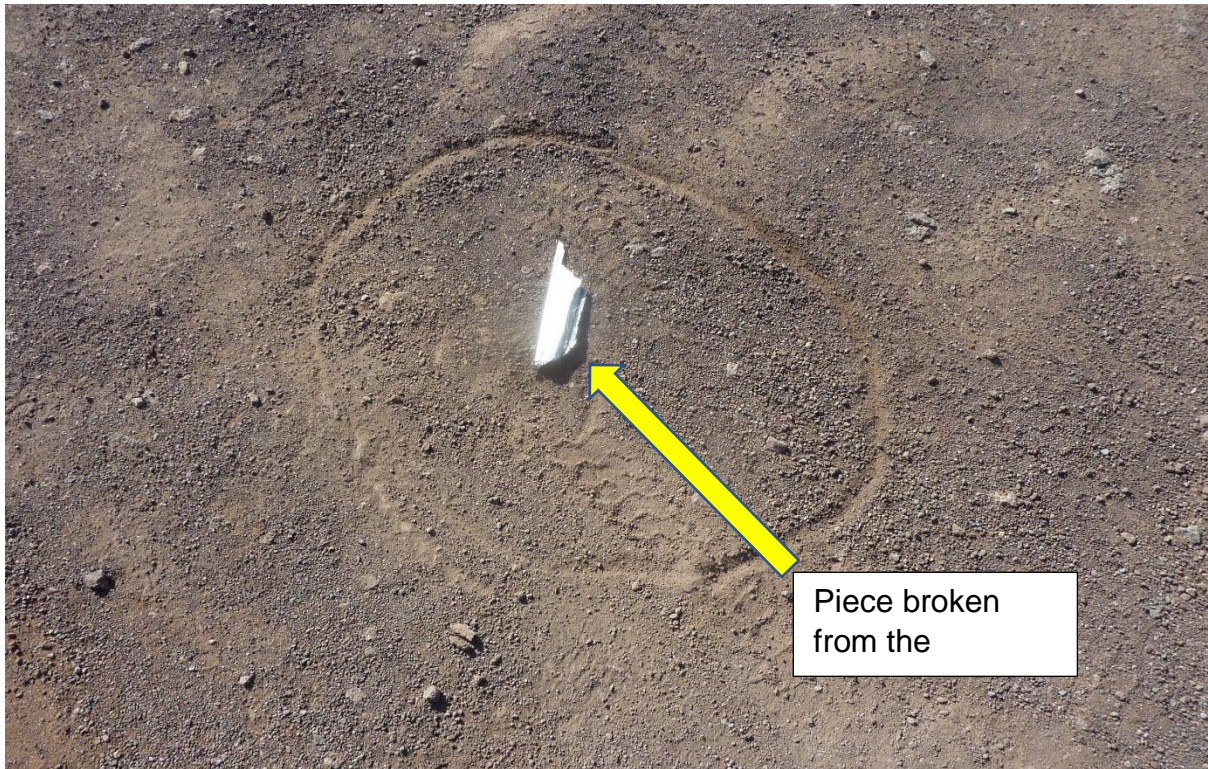
Piece broken
from the

Fig. 5.1: Broken Propeller Piece

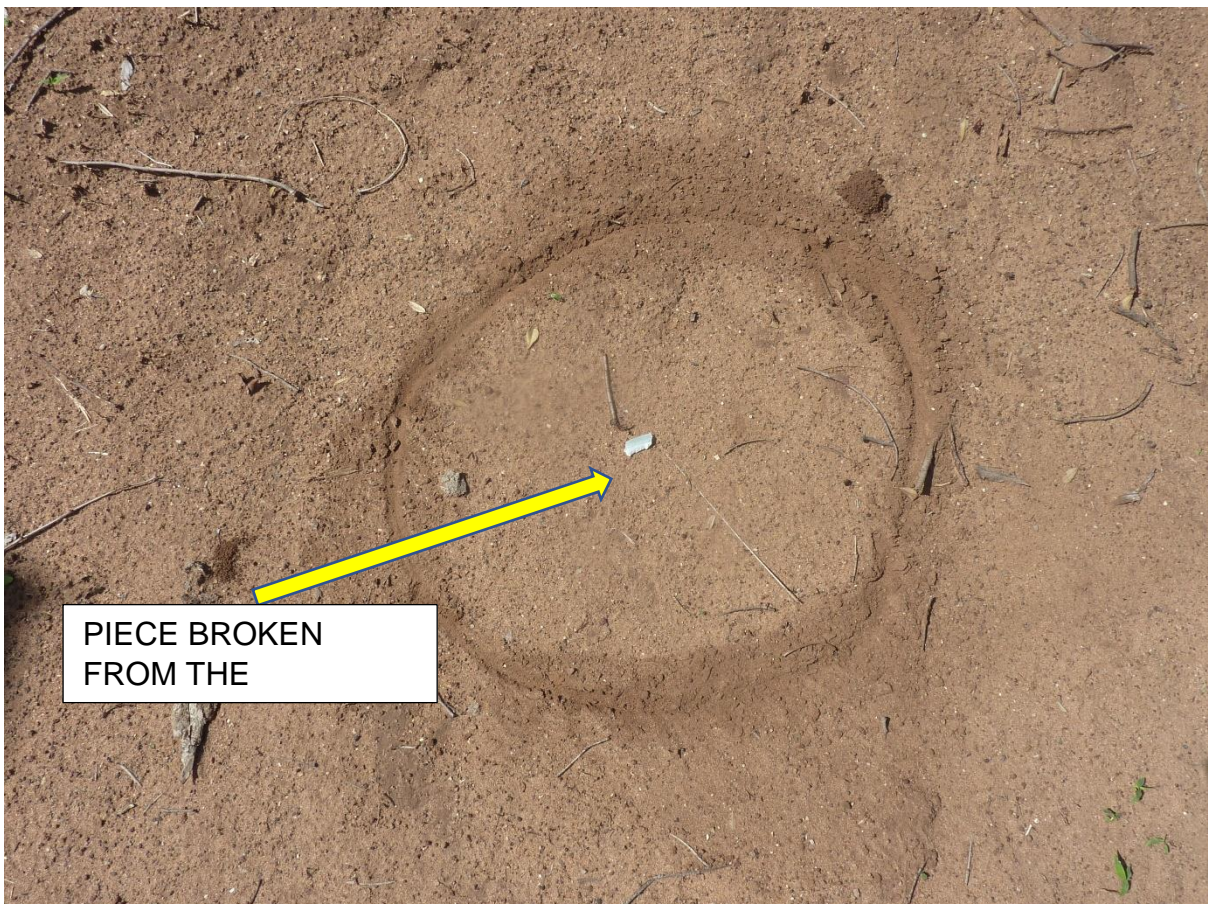
PIECE BROKEN
FROM THE

Fig. 5.2: Broken Propeller Piece

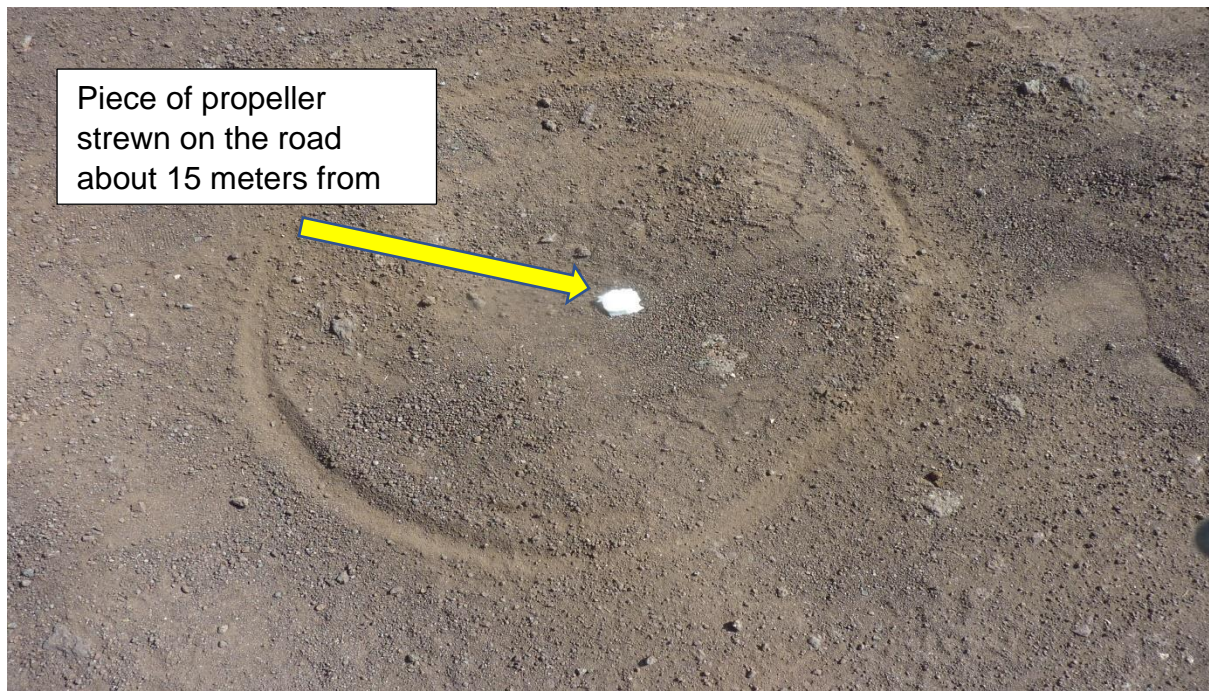
Fig. 5.3: Broken Propeller Piece on the Road

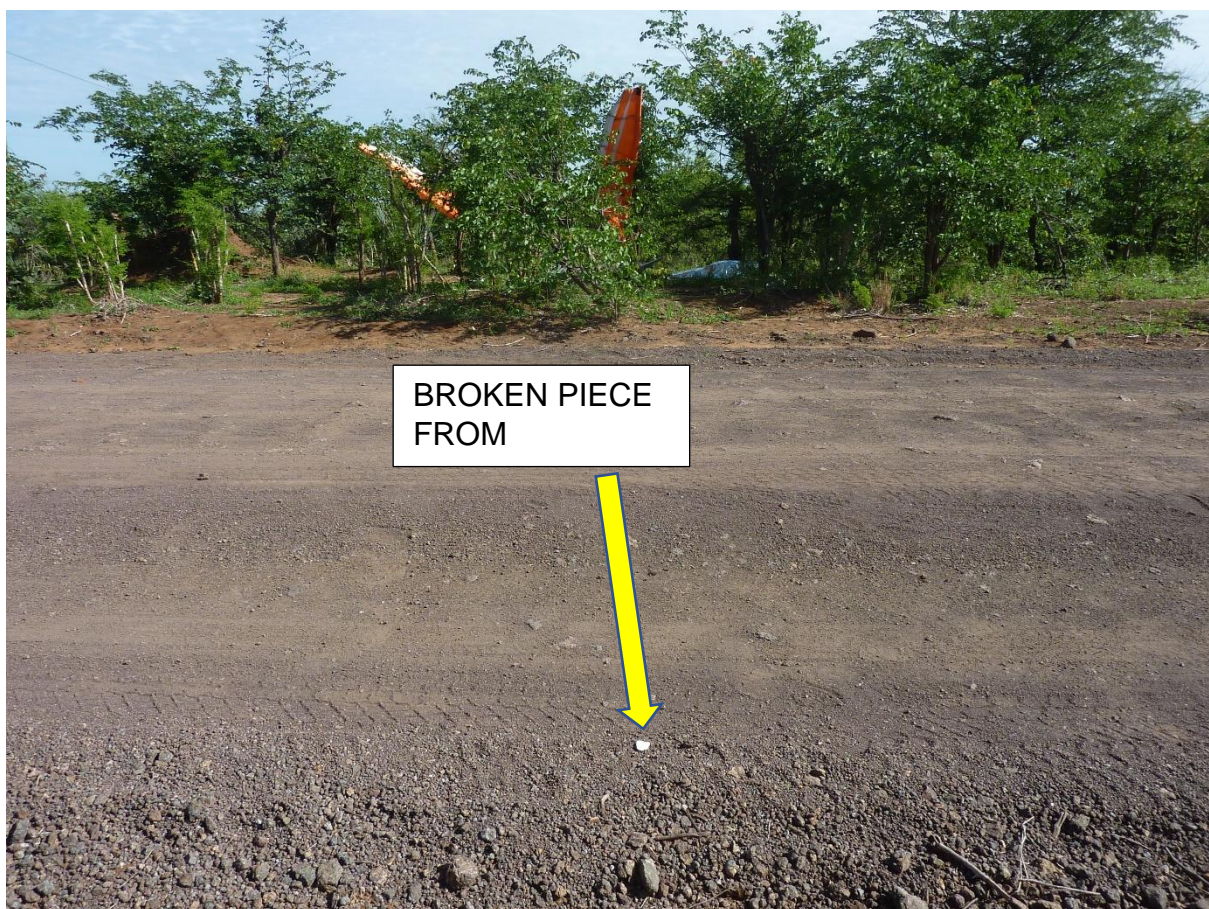
Fig.5.4: Broken propeller piece on the Road

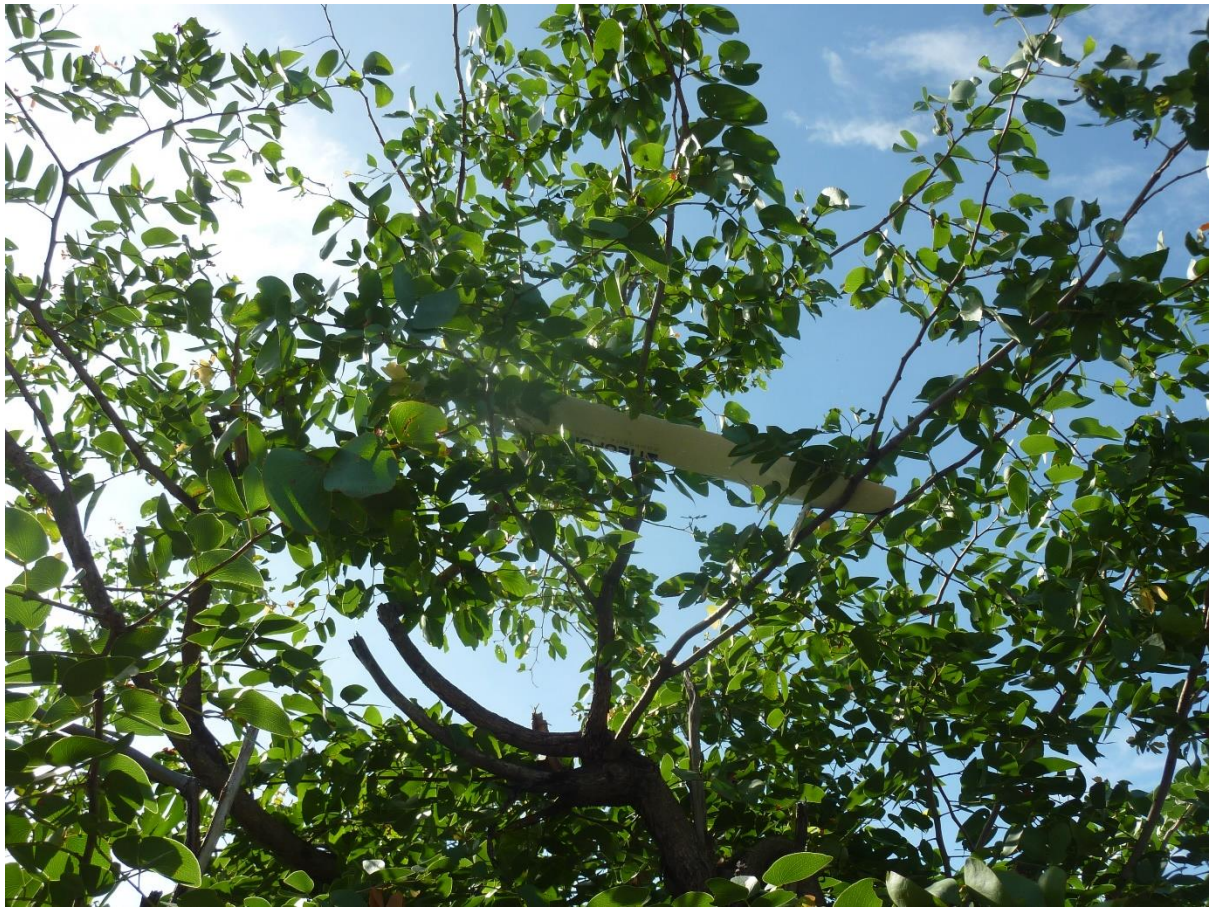
(3) Propeller blades Damaged (Fig. 5.5)

One blade was damaged into the portion about 10 cm from its hub end and the forward Pilot's seat frame was deformed. Both seat pans were found about the original position.

Fig.5.5: Propeller Piece among branches

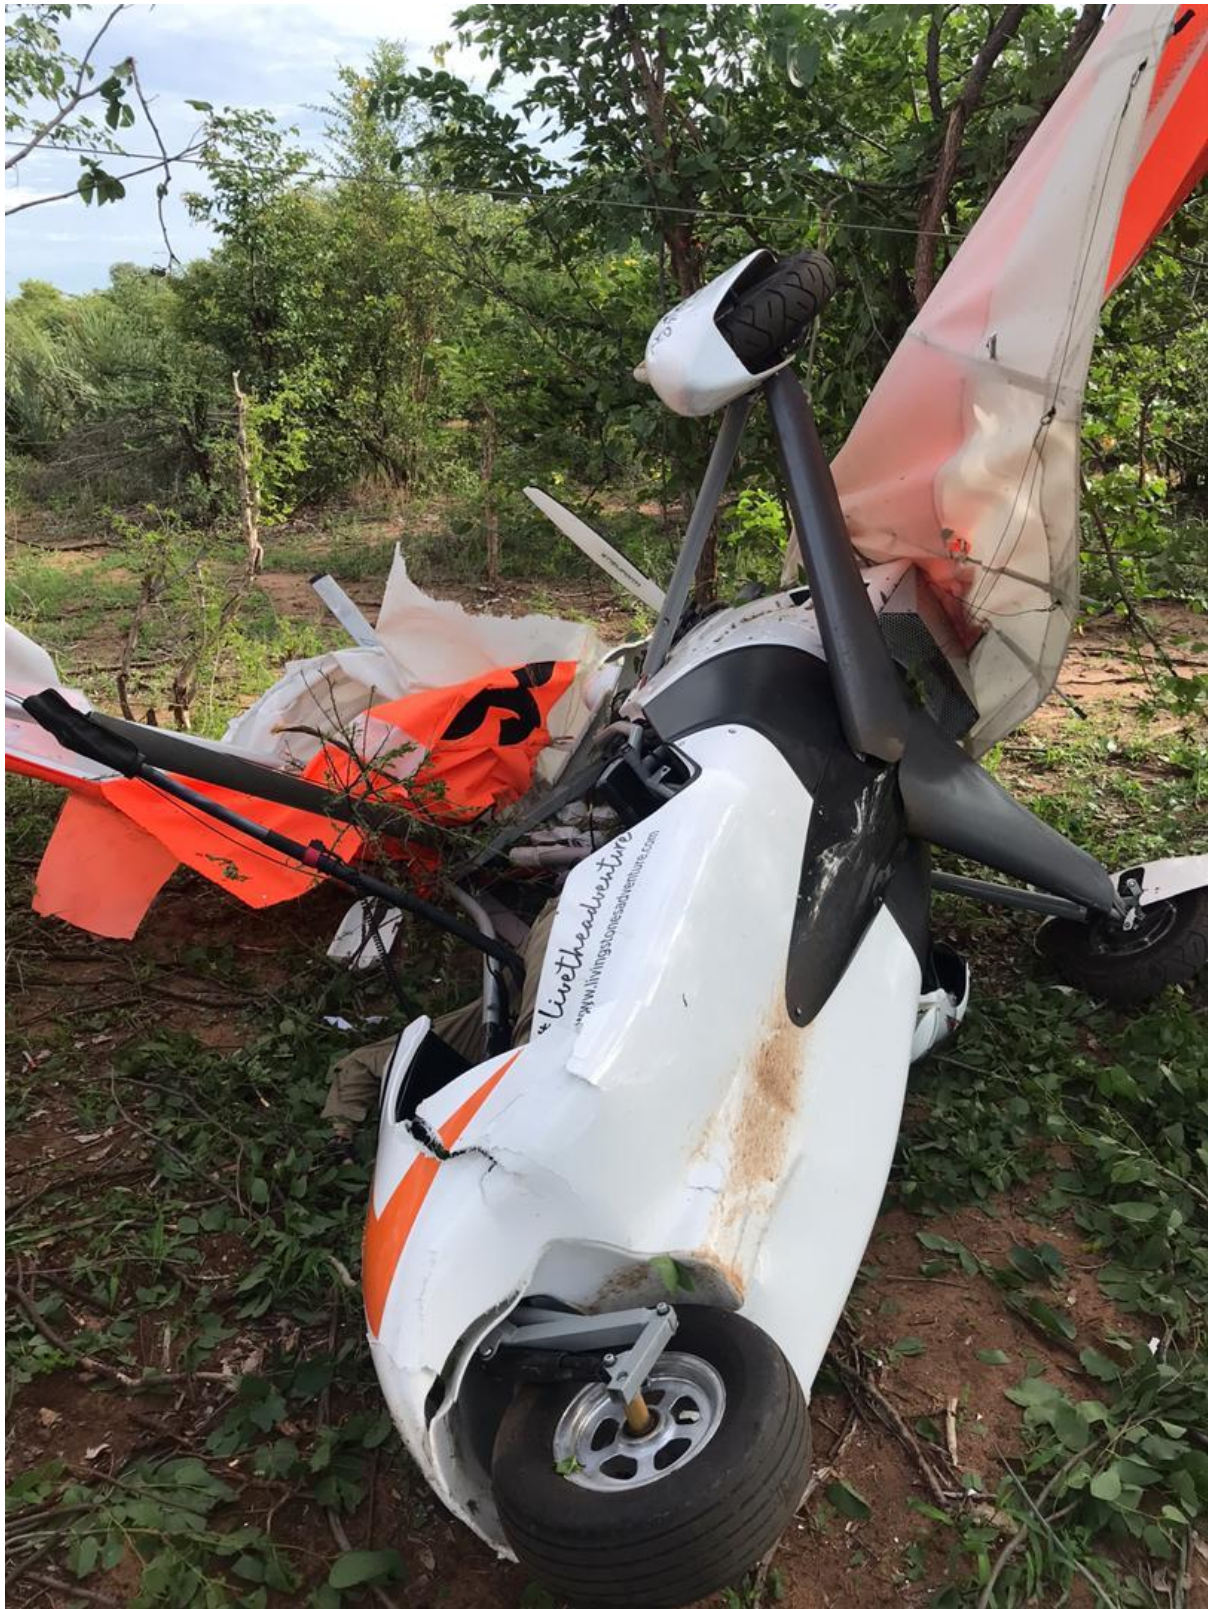
The aircraft was substantially damaged. (Fig 6.1)

Fig 6.1: Microlight at Point of Ground Impact

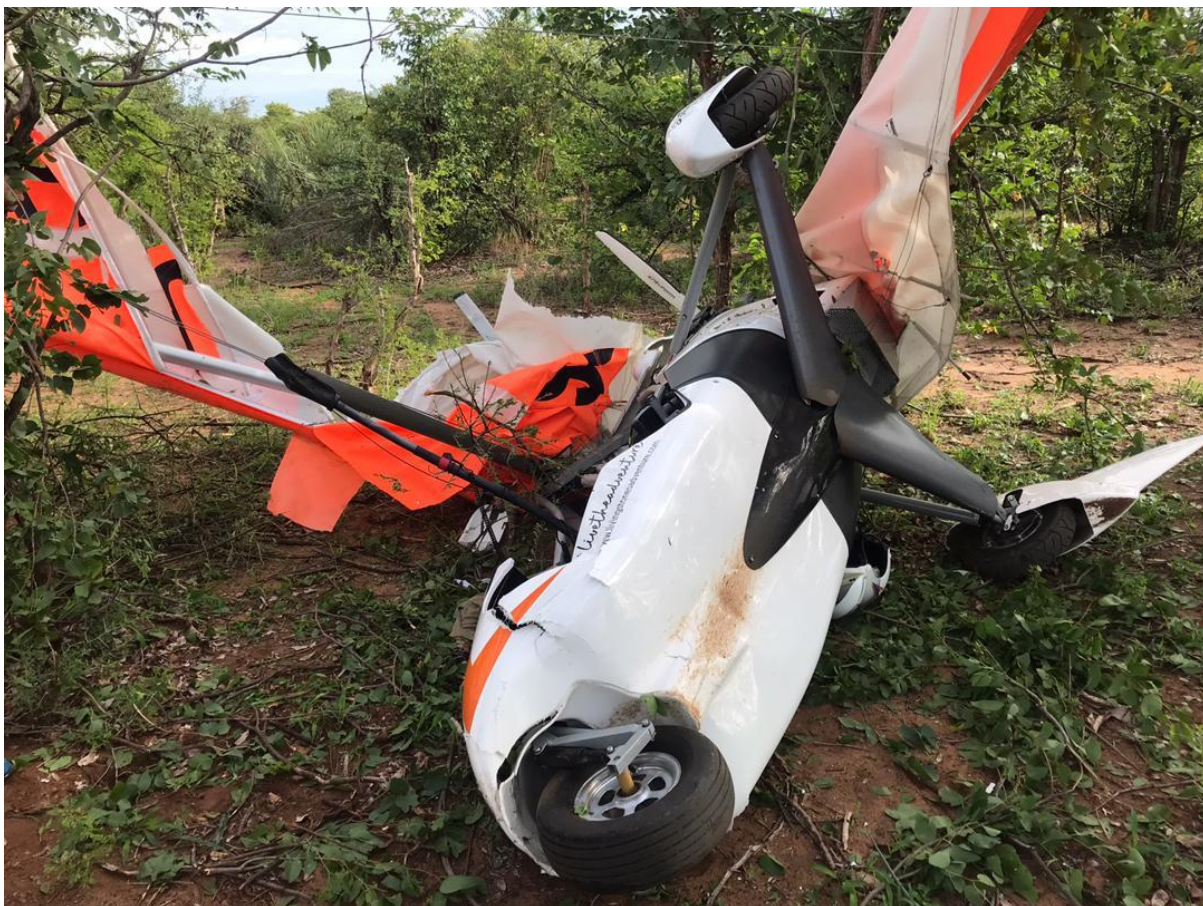
Fig 6.2: Microlight at Point of Ground Impact

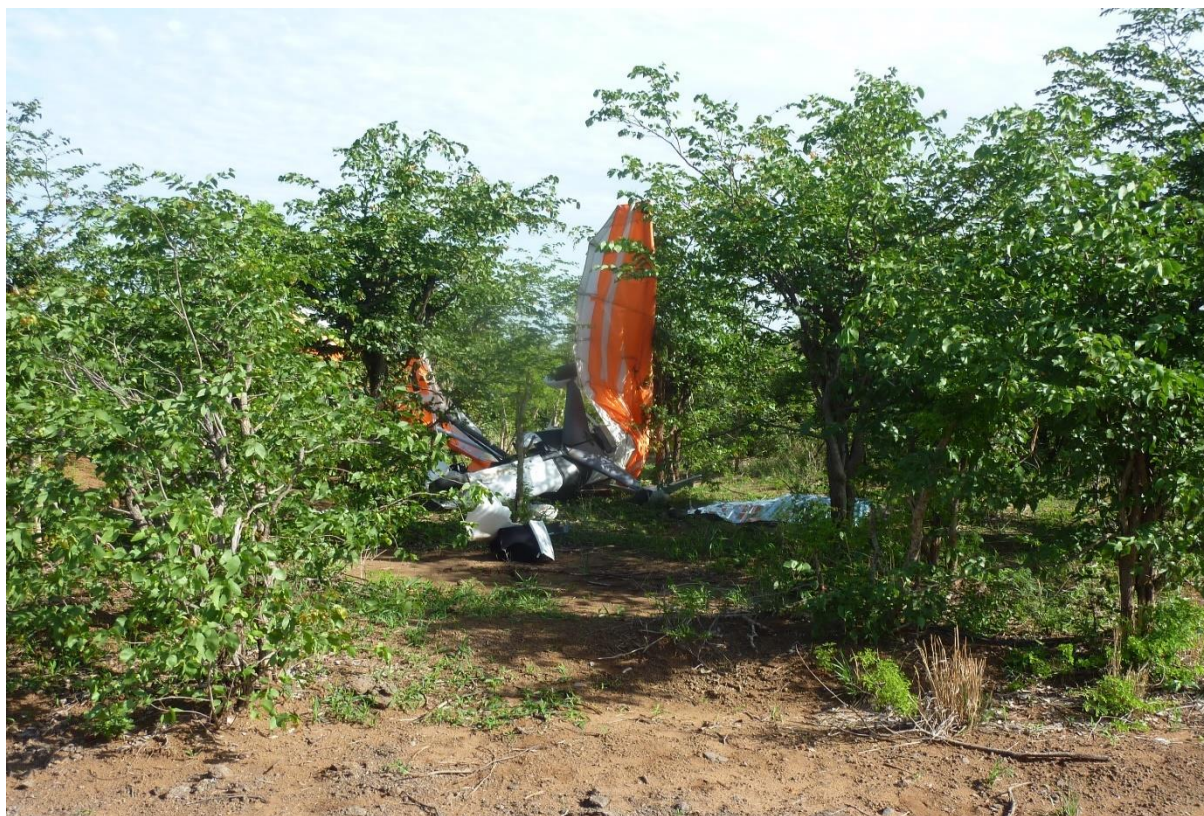
Fig.6.3: Microlight at Point of Impact

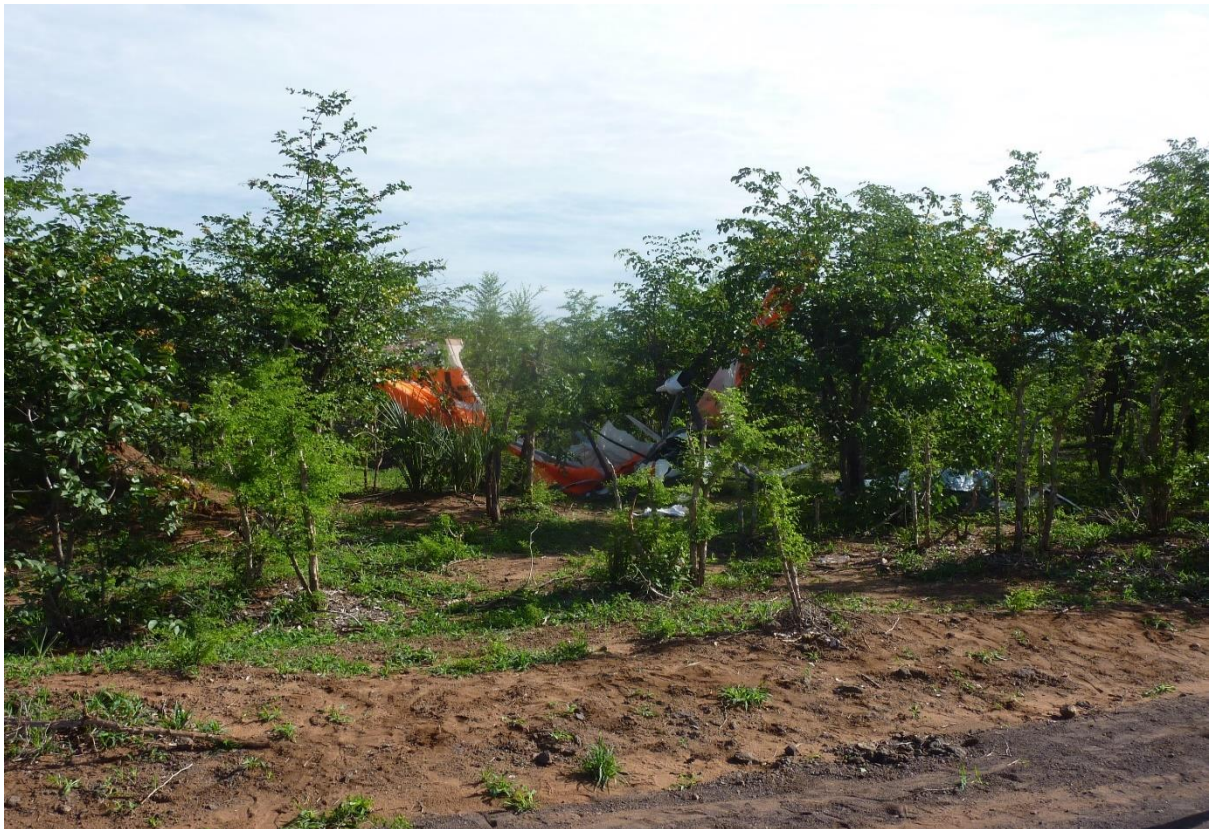
Fig.6.4: Microlight at Point of Impact from road side

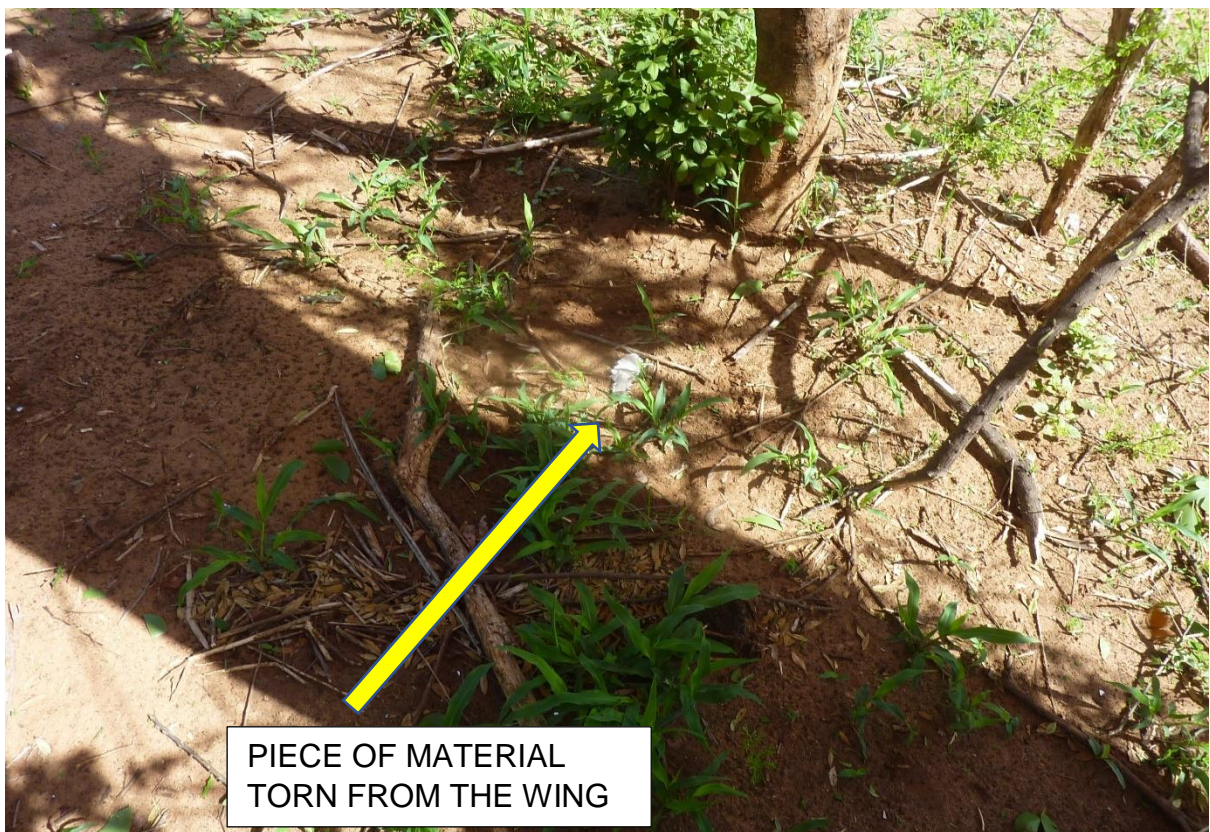
PIECE OF MATERIAL
TORN FROM THE WING

Fig.7: Material Torn From the Wing

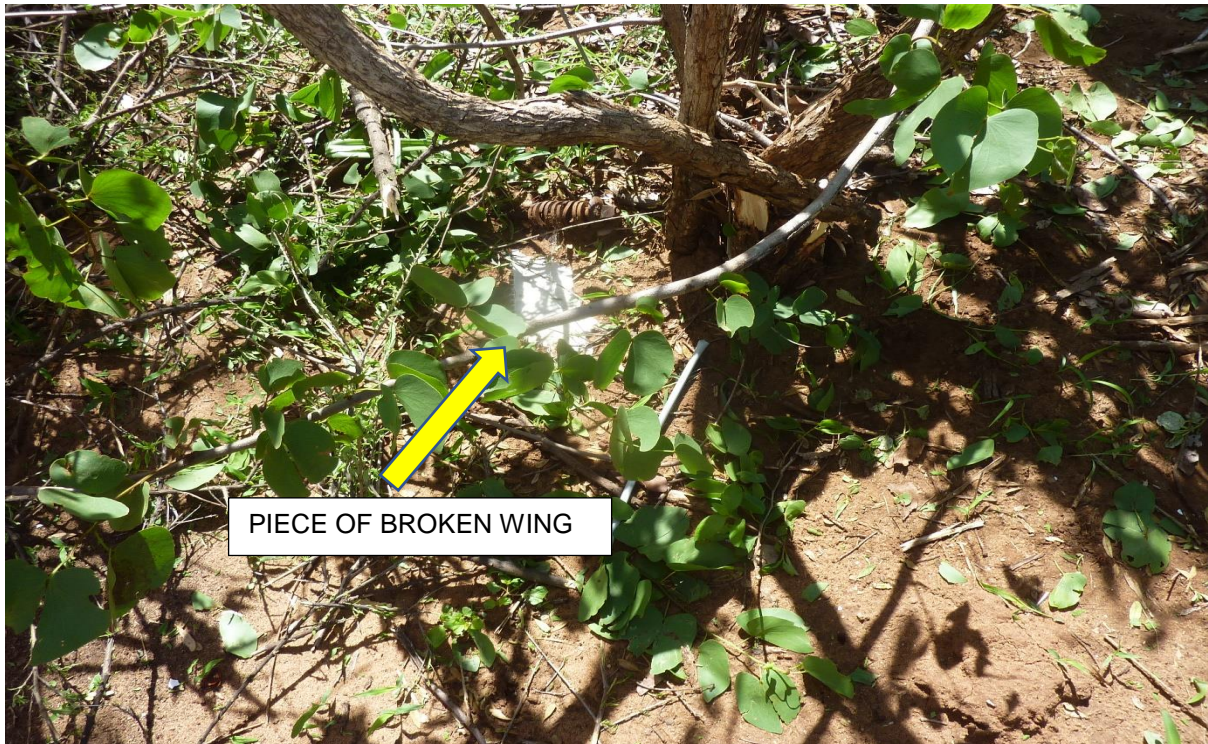
Fig.8 Piece of Broken Wing

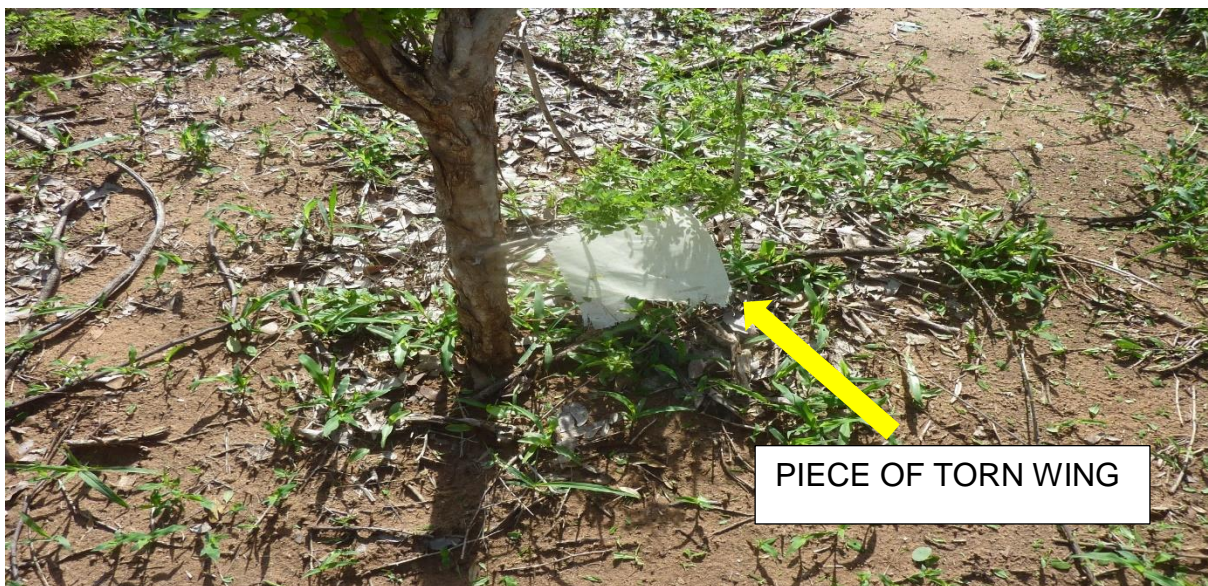
Fig.9 Piece of Torn Wing

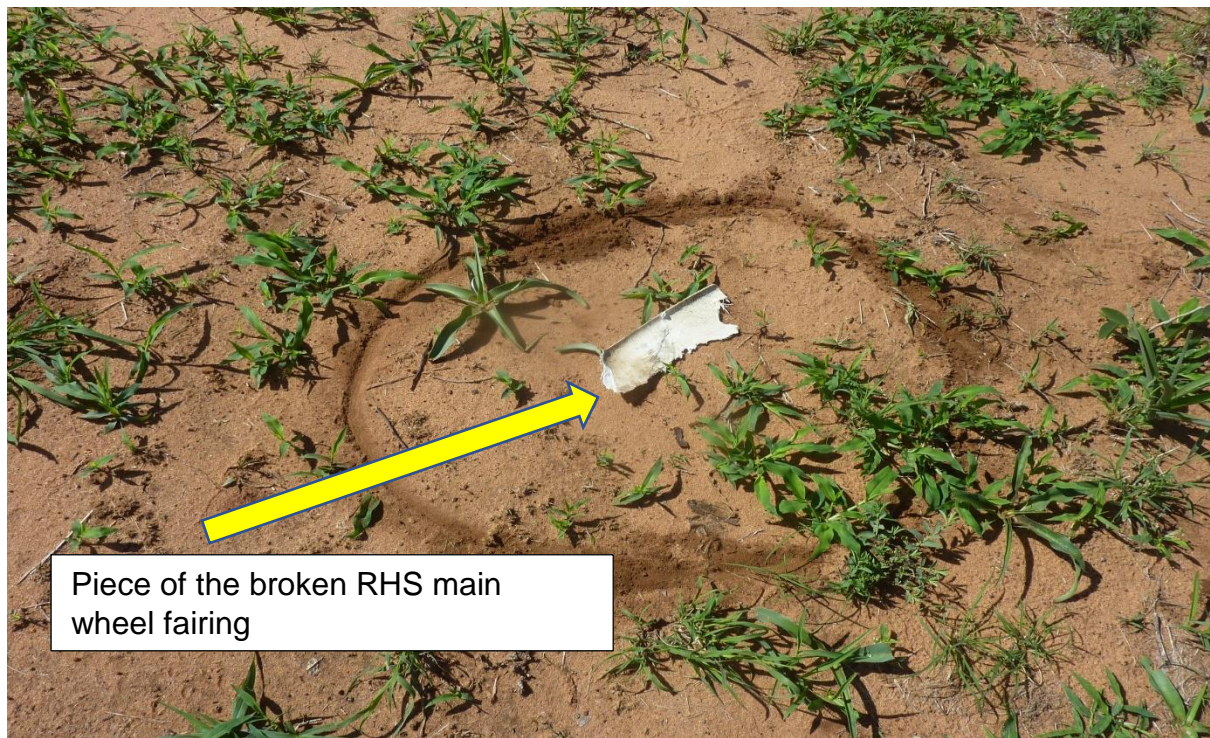
Fig.10 Piece of Broken RHS Main Wheel-Fairing

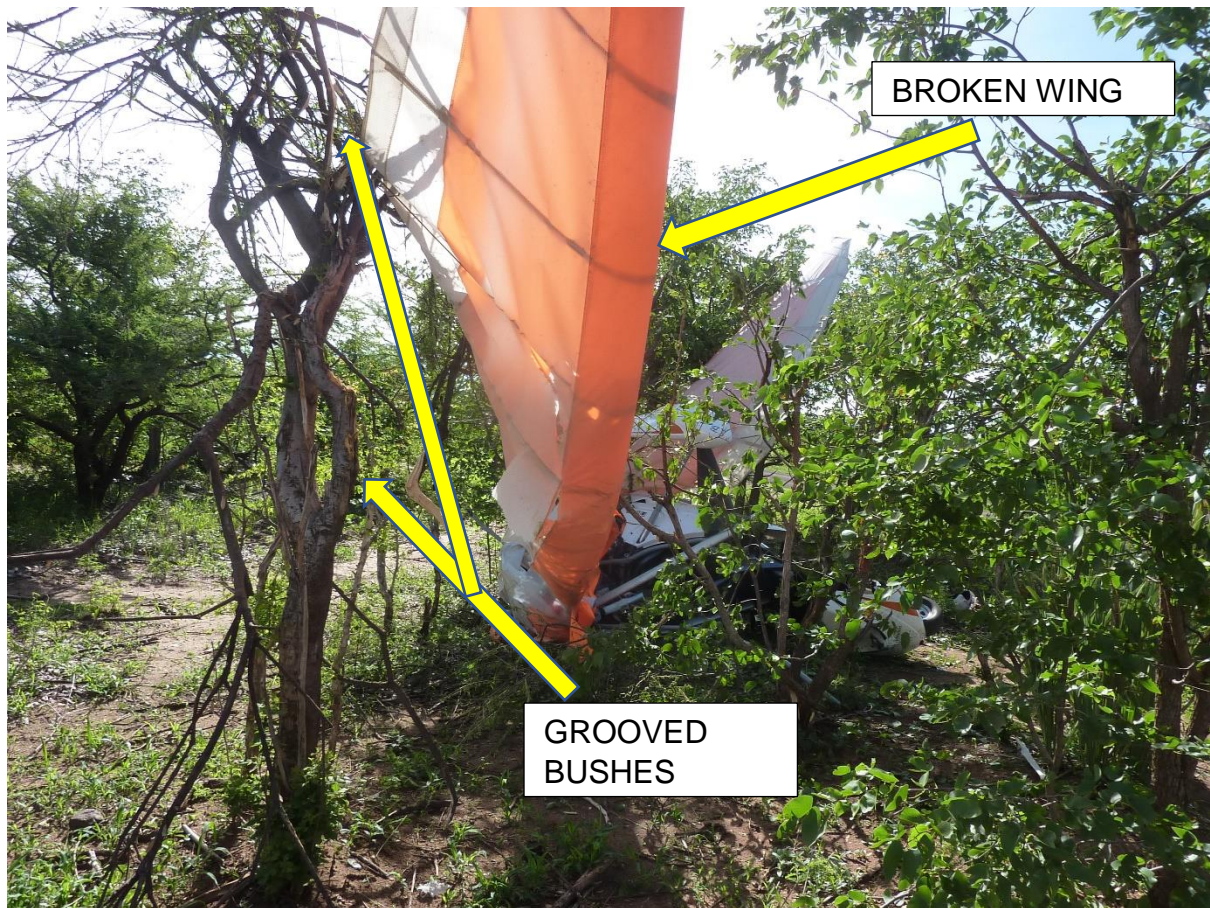
(4) Wing Structure Damaged (Fig. 11)

The whole assembly was completely damaged with most tubes either fractured or bent. (Fig.11)

Fig.11: Microlight showing Broken Wing and Grooved Bushes
